# TUDELU, LLC ACOUSTICAL PERFORMANCE TEST REPORT

ASTM E90 SOUND TRANSMISSION LOSS TESTING ON TUDELU MUTE ACOUSTICAL PANELS

P3024.01-113-11-R0

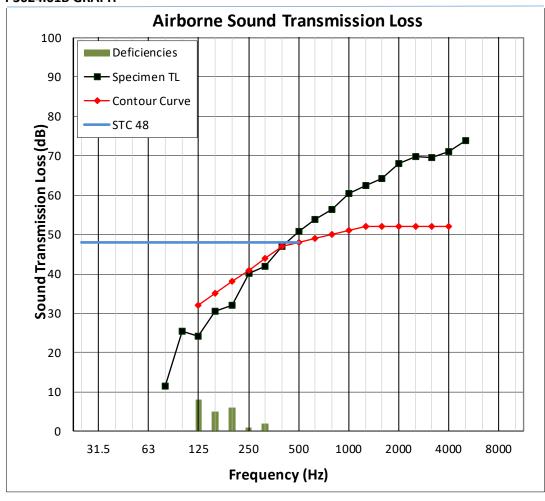
# P3024.01B GRAPH

FREQ	BACKGROUND	ABSORPTION	SOURCE	RECEIVE	SPECIMEN	95%	NUMBER
	SPL		SPL	SPL	TL	SAMPLING	OF
(Hz)	(dB)	(m²)	(dB)	(dB)	(dB)	LIMIT	DEFICIENCIES
80	34.8	6.3	105	89	12	2.89	-
100	31.1	6.2	106	77	25	1.42	-
125	33.7	5.6	107	79	24	1.37	8
160	39.9	4.7	108	75	30	1.06	5
200	37.1	5.6	108	72	32	0.71	6
250	34.4	6.0	104	60	40	0.78	1
315	30.4	5.6	105	59	42	0.58	2
400	24.1	5.6	104	53	47	0.54	0
500	19.8	5.5	104	49	51	0.37	0
630	17.7	5.6	104	47	54	0.27	0
800	17.4	6.0	102	42	56	0.22	0
1000	11.3	6.0	104	39	61	0.28	0
1250	9.3	6.5	102	35	62	0.15	0
1600	6.8	6.9	99	30	64	0.18	0
2000	6.8	7.4	102	28	68	0.25	0
2500	6.5	8.7	103	27	70	0.27	0
3150	6.8	10.6	101	25	69	0.24	0
4000	7.7	13.6	99	20	71	0.28	0
5000	8.4	17.5	99	17	74	0.34	-
STC RATIN	IG	48	(Sound Transmission Class)				
DEFICIENC	CIES	22	(Sum of Defi	ciencies)			
OITC RATI	NG	30	(Outdoor-Indoor Transmission Class)

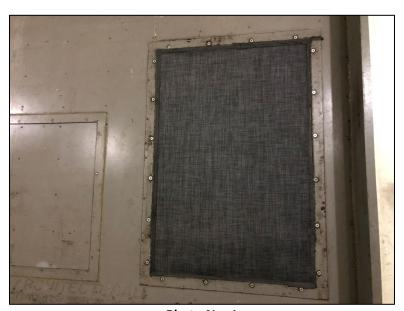
Photo No. 1
Receive Room View of Installed Test Specimen

Tudelu Mute acoustical panels consisted of one 48" by 72" frame constructed with 1-1/2" thick by 4" wide wood lumber and fastened together with screws. One layer fabric-faced mass loaded vinyl was screwed to the wood frame on both sides, creating the 4" air space. The fabric-faced mass loaded vinyl had a 5 mm (3/16") felt backing faced toward the inner side of the test specimen on both sides.

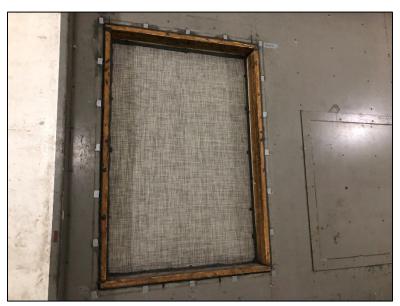
Photo No. 2 Source Room View of Installed Test Specimen
